Manhole Inspection Summary

Manhole # S51II_025MH

Insp Date: **8/5/08 11:25 AM**

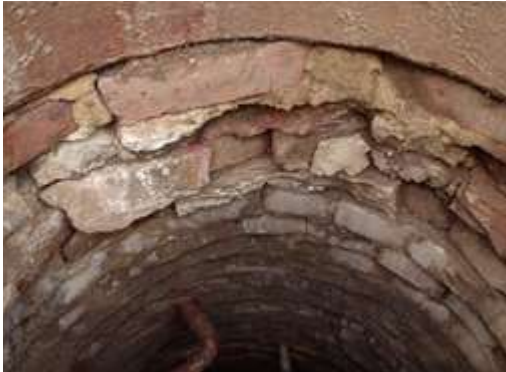
Defect 2

Condition: ☐ Sound ☐ Cracked ☐ Root Intrusion ☒ **Loose Brick** ☐ Deteriorated

Loose brick

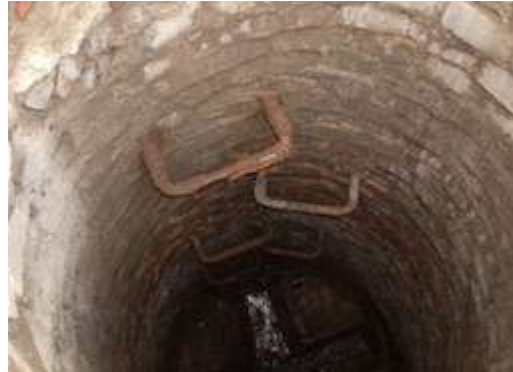
Defect 1

Infiltration: ☐ None ☒ **Joint** ☐ Cracks ☒ **Mortar** ☐ Roots ☒ **Wall**

Infiltration

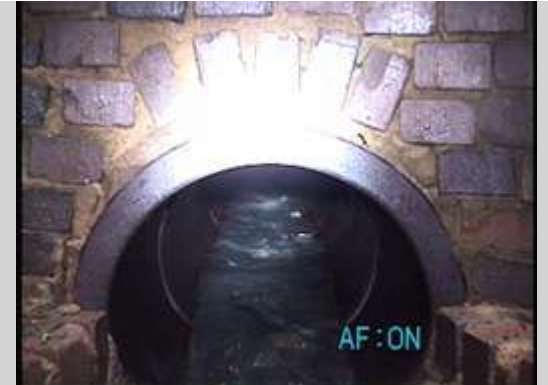
12 O'Clock Outflow

21 in. Circular Gravity Sewer
Pipe Out @ 12 O'Clock

Pipe Height: **20.4** (in.) Rod and Bar (Angled)
Pipe Material: **Clay** ☐ Pipe Lined
Invert Depth: **13.40** (ft.) Flow Characteristics: **Fast**
Deposits: ☒ None ☐ Mud ☐ Sludge ☐ Debris ☐ Grease
Silt Depth: (in.) Deposits Extent:
Infiltration: **None** Pipe Seal Cond: **Sound**

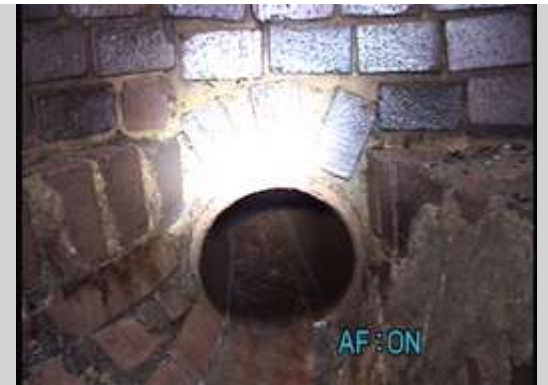
3 O'Clock Inflow

8 in. Circular Gravity Sewer
Pipe In @ 3 O'Clock

Pipe Height: **8.4** (in.) Rod and Bar (Angled)
Pipe Material: **Clay** ☐ Pipe Lined
Invert Depth: **13.20** (ft.) Flow Characteristics: **Fast**
Deposits: ☒ None ☐ Mud ☐ Sludge ☐ Debris ☐ Grease
Silt Depth: (in.) Deposits Extent:
Infiltration: **None** Pipe Seal Cond: **Sound**

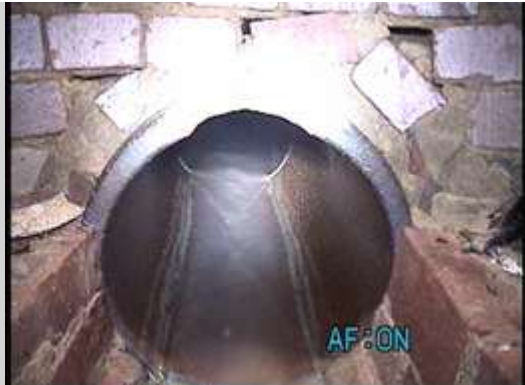
6 O'Clock Inflow

Infiltration: **None** Pipe Seal Cond: **Sound**

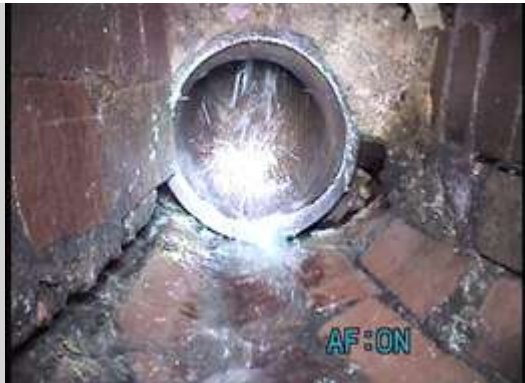
9 O'Clock Inflow

Infiltration: **None** Pipe Seal Cond: **Sound**
